National Dam Inspection Program.
Carbondale Number 4 Dam (NDI ID Number
PA-00384, DER ID Number 35-13),
Susquehanna River Basin, Racket Brook,
Lackawanna County, Pennsylvania.

Phase I Inspection Report.

NDI ID No. PA-00384
DER ID No. 35-13

(11) FEBRUARY 1979

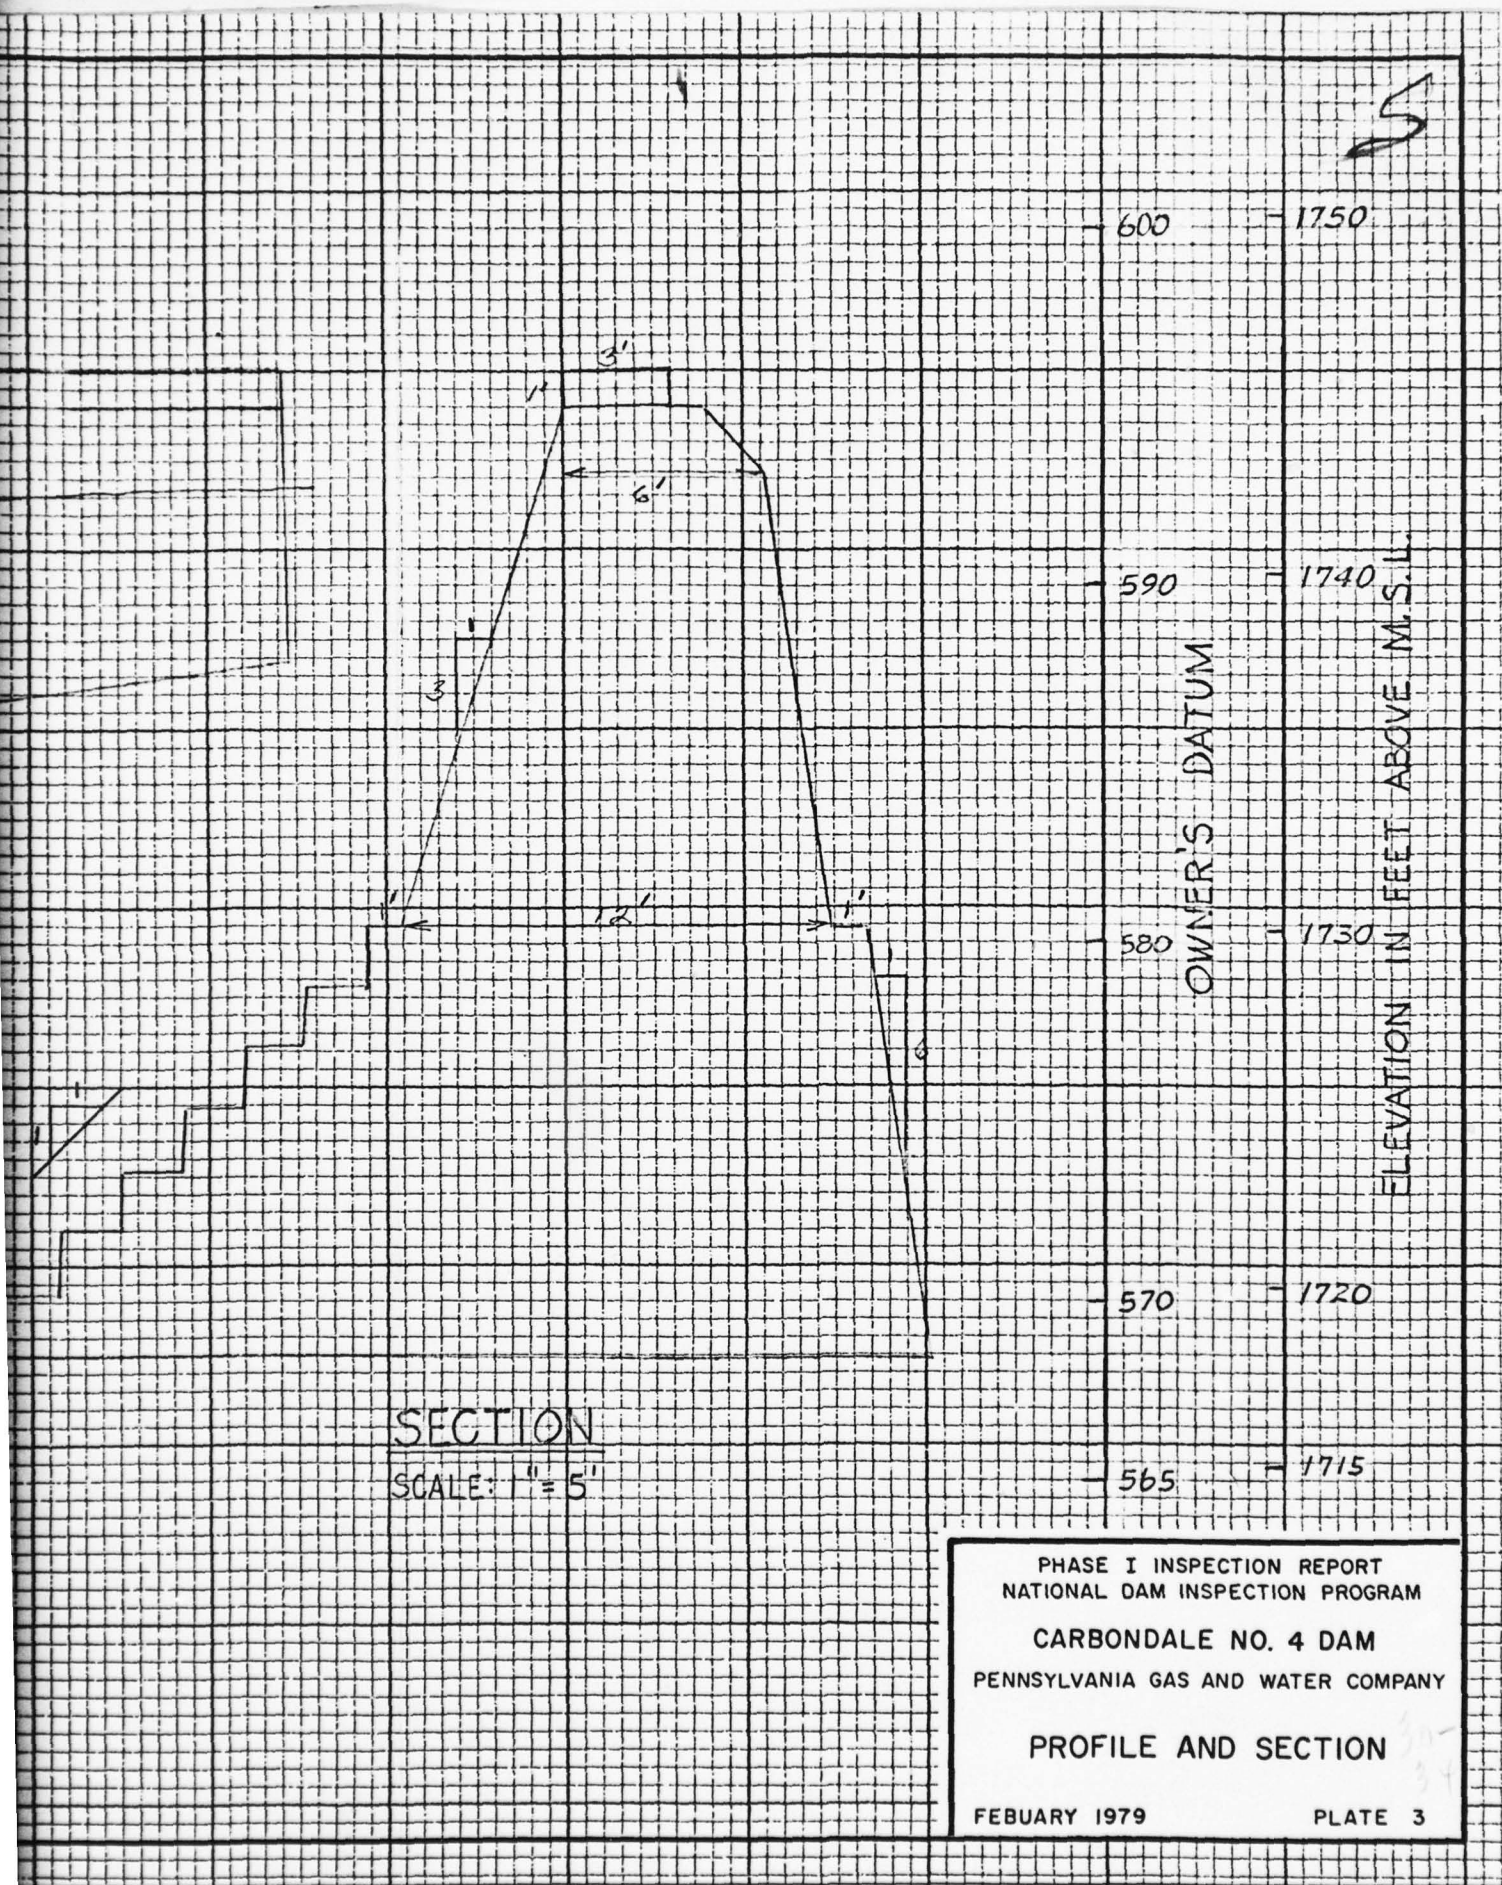
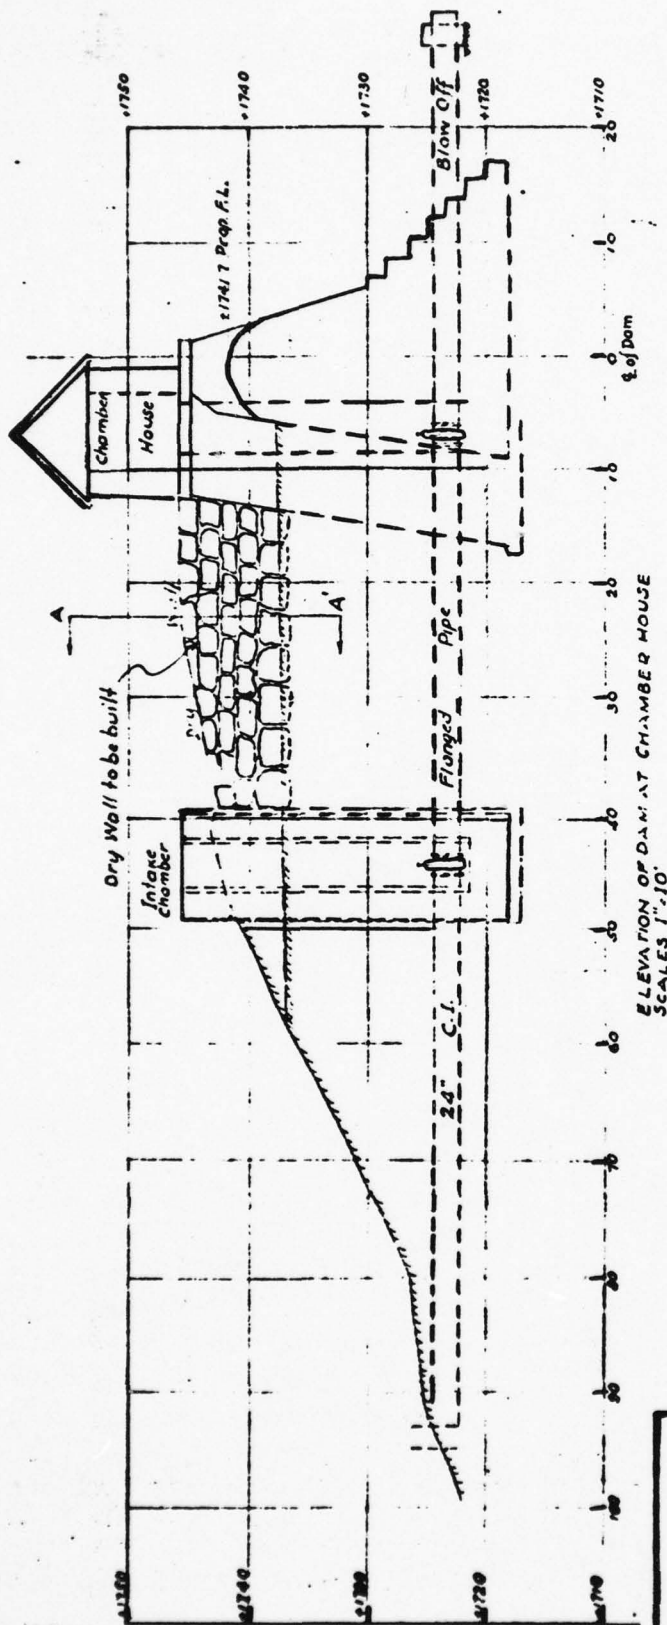
PLATE 3

b. Design Features. The dam and appurtenances are described in Paragraph 1.2a. The design features are shown on the Plates at the end of the report and on the Photographs in Appendix D. Plate 2 shows a plan of the dam. Plate 3 and Photographs A and B show the profile and a section of the masonry. This plate was drawn before the 1945 modifications to the dam and it shows the original spillway at the left abutment. Plate 4 and Photographs C, D, and E show a profile of the existing spillway and outlet works. The outlet works pipe is extended further, as shown on Plate 2. The extension is noted as a 30-inch diameter pipe; the extension is actually 36-inches in diameter. The other pipe, parallel to the outlet works pipe on Plate 2, apparently connects to a drain from the valve house.
